**Extractive Industry Application
and
Management Plans**

**No. 148 Mount Leewin Loop Road
Carlotta, Shire of Nannup**

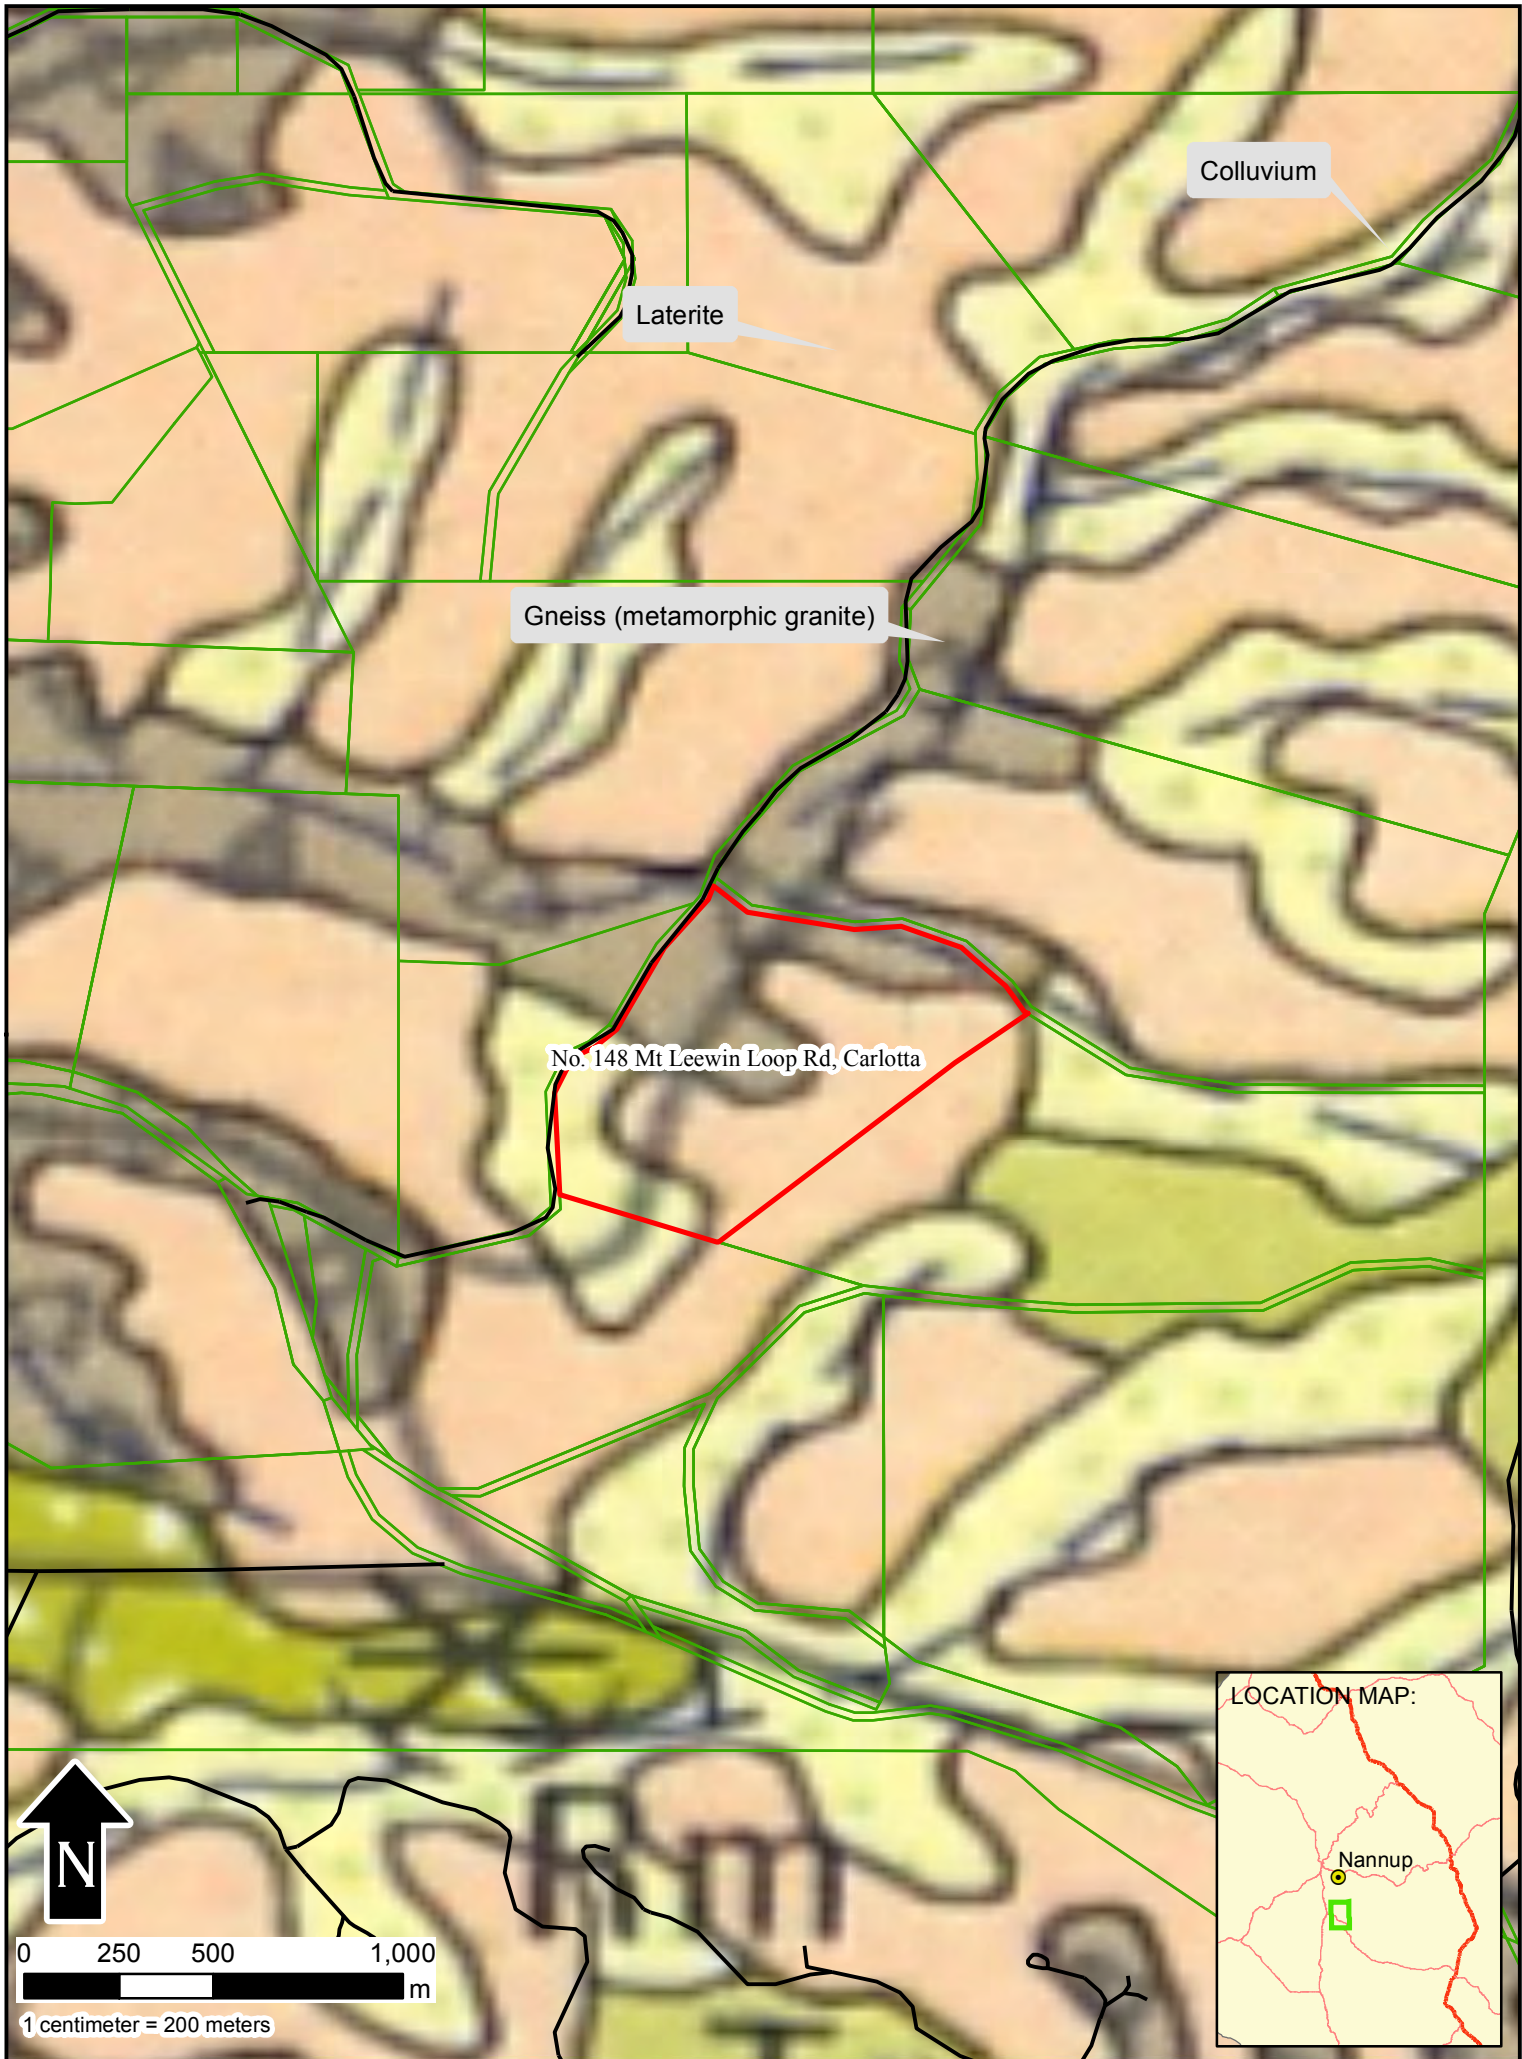
The laterite (which comprises the main area for excavation – pisolitic gravel) is a rock type rich in iron and aluminium and the local laterite is red coloured, indicating it is high in iron oxide content. The colluvium is primarily loose, unconsolidated sediment that has been deposited at the base of hillslopes via a range of processes, including via rain (Dept. Mines and Petroleum, Map Sheet si5010, Pemberton). Previous Quality of Materials Reports describe the material Type as Brown Gravel (ranging from Brown Clayey Silty Gravel to Brown Clay Gravel).

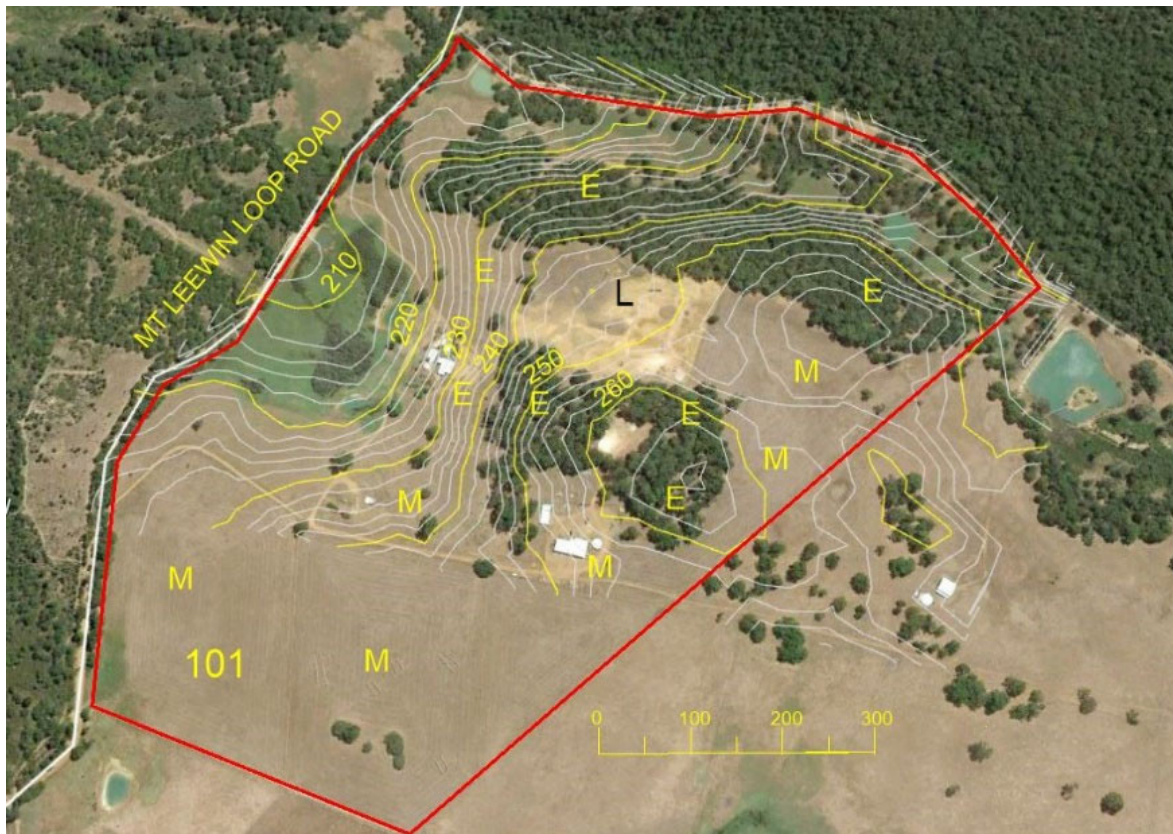
Figure 4: Contours and Hazard Levels Lot 101

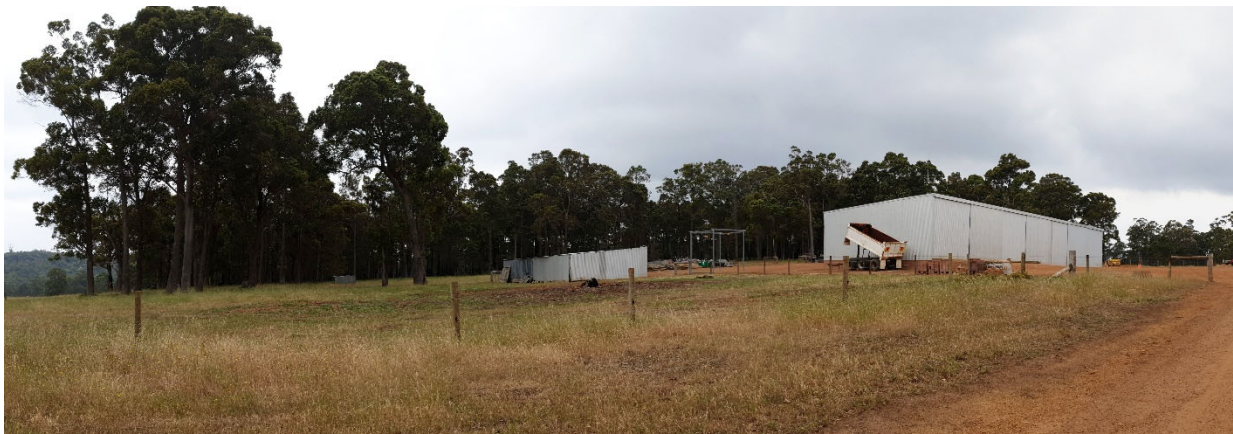
Fig 6: The main shed.

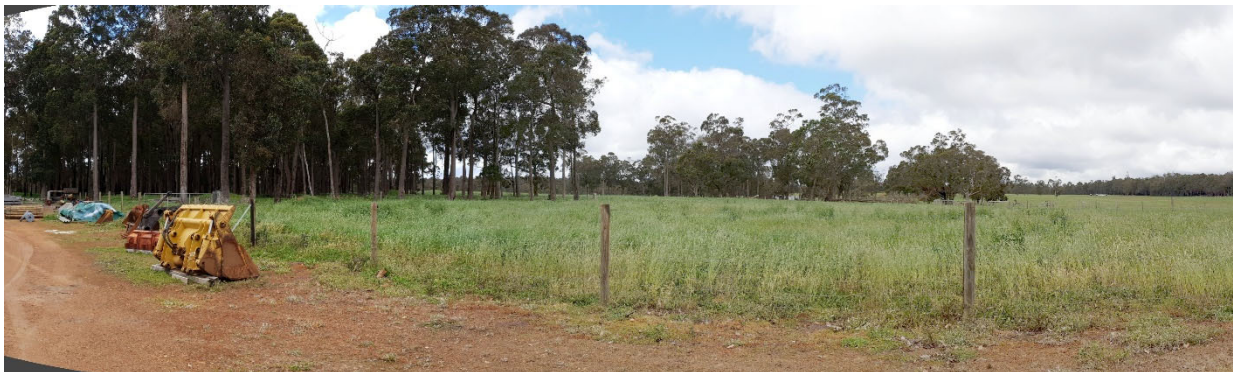
Figure 9: East paddock under crop as at 18 October 2018. This was to be slashed and baled by November 1.

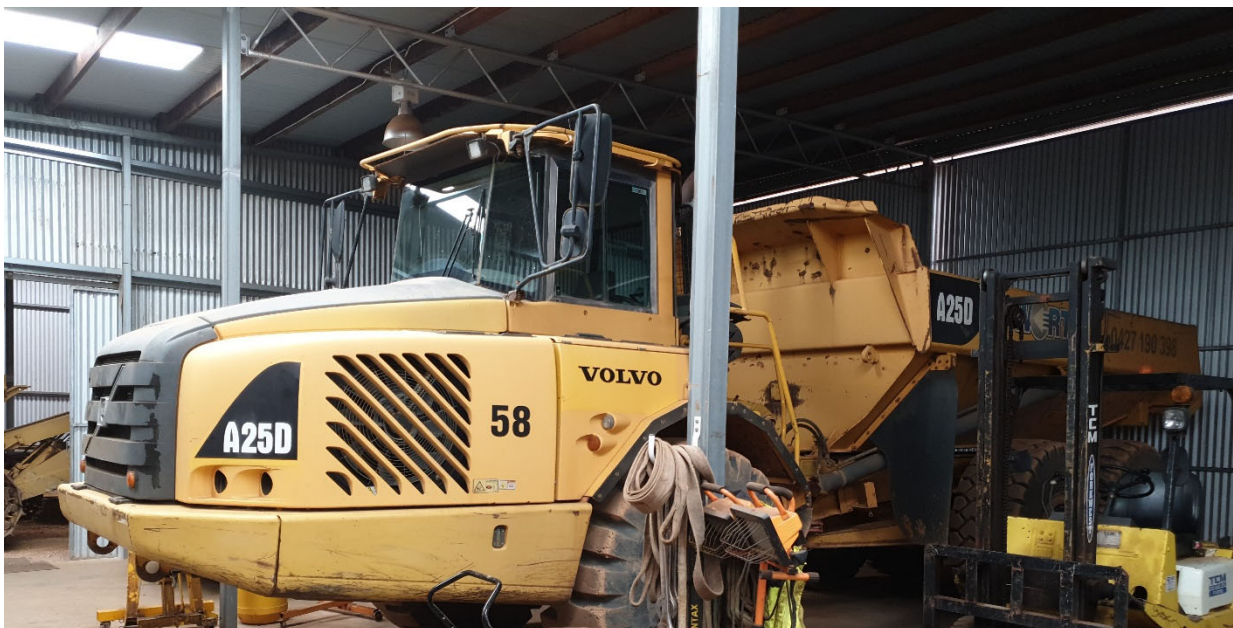
Fig. 10: Typical heavy plant stored in Shed.
