Shire of
Nannup
rest • connect • grow

Asset Management Plan

2013-2023

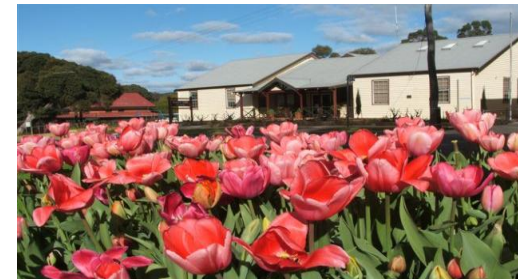
Asset Name	Shire Administration	Asset Number	B10	Core, Non-Core or Disposable
Type (B, L or E)	B	Asset Level	Core	
Address	5 Adam Street	Asset Condition	2	
Location	Nannup	Acceptable Condition		Good 0 - 10 Poor
Reserve No:	29142	Reserve Class:		
DOLA Plan	P186227	DOLA Pin		
Assessment No:	A962	Legal Area		
Aerial View	R29142	MAP View		
Replacement Value	\$ 2,150,000.00	As at:	1/12/2011	
Built Year		Inspected:	AVP Valuations - Jeff Cadd	
Fair Value	\$ 804,000	Contact Details	08 9328 3800	
Ownership Held	Reserve	Expiry/Renewal Date:	1/12/2045	
Lease Details	Remaining Life 34 Years			
Description	Timber weatherboard and iron clad air conditioned administration offices and library on concrete footings with timber floors.			
Comments	Shire administration building consists of Library, Council Chambers, Function Room and Offices

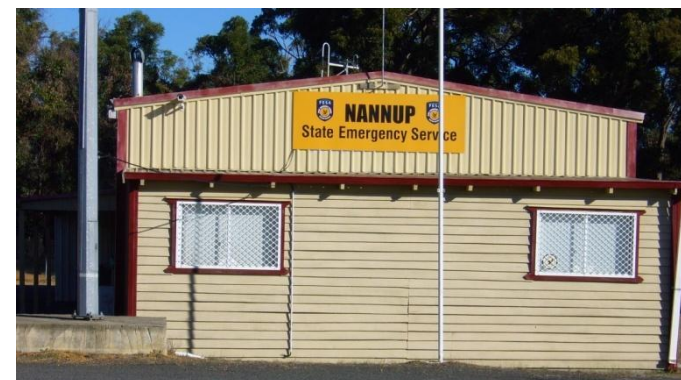
Asset Name	SES Shed	Asset Number	B47	Core, Non-Core or Disposable
Type (B, L or E)	B	Asset Level	Core	
Address	Sexton Way, Nannup	Asset Condition	3	
Location	NANNUP	Acceptable Condition		Good 0 - 10 Poor
Reserve No:	R45178	Reserve Class:		
DOLA Plan		DOLA Pin		
Assessment No:		Legal Area		
Aerial View		MAP View		
Replacement Value	\$ 325,000.00	As at:	1/12/2011	
Built Year		Inspected:	AVP Valuations - Jeff Cadd	
Fair Value	\$ 206,000.00	Contact Details	08 9328 3800	
Ownership Held		Expiry/Renewal Date:	1/12/2058	
Lease Details				
Description	Iron and iron clad general purpose shed on concrete footings and slab with office and amenities			
Comments

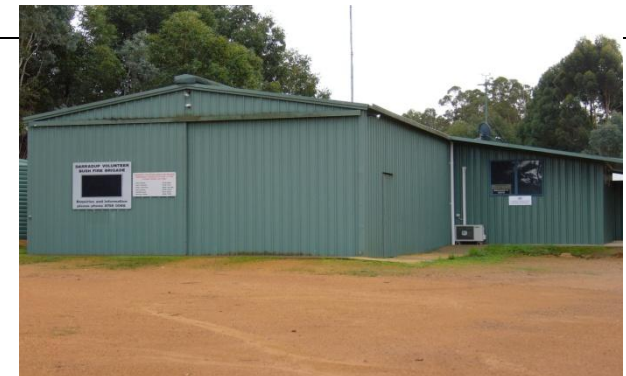
Asset Name	Darradup Fire Station	Asset Number	B34	Core, Non-Core or Disposable Good 0 - 10 Poor Good 0 - 10 Poor
Type (B, L or E)	B	Asset Level	Core	
Address	Johnston Road, Darradup	Asset Condition	3	
Location	NANNUP	Acceptable Condition		
Reserve No:	R43352	Reserve Class:		
DOLA Plan		DOLA Pin		
Assessment No:		Legal Area	0.1215	
Aerial View		MAP View		
Replacement Value	\$ 400,000.00	As at:	1/12/2011	
Built Year		Inspected:	AVP Valuations - Jeff Cadd	
Fair Value	\$ 250,000.00	Contact Details	08 9328 3800	
Ownership Held			Expiry/Renewal Date:	1/12/2068
Lease Details				
Description	Iron & Iron Clad emergency services depot on concrete footings and slab with single sliding door. Includes store shed, patios, paving, bbq and rainwater tanks.			
Comments

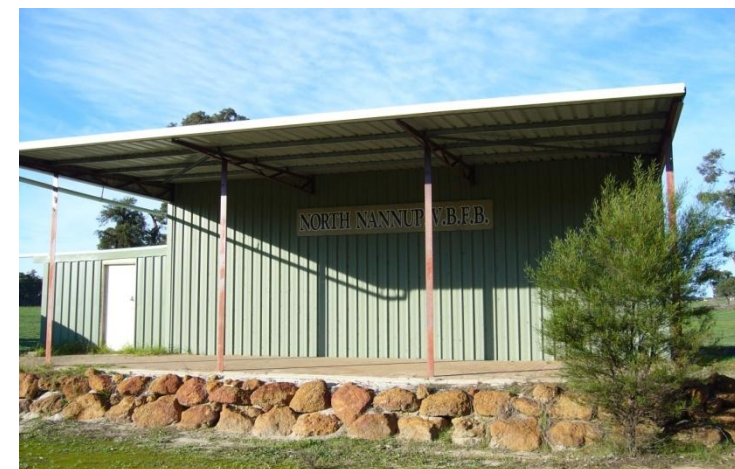
Asset Name	North Nannup Fire Station	Asset Number	B36	Core, Non-Core or Disposable Good 0 - 10 Poor Good 0 - 10 Poor
Type (B, L or E)	B	Asset Level	Core	
Address	Dean Road	Asset Condition	2	
Location	NANNUP	Acceptable Condition		
Reserve No:	R46845	Reserve Class:		
DOLA Plan		DOLA Pin		
Assessment No:		Legal Area	0.1171	
Aerial View		MAP View		
Replacement Value	\$ 115,000.00	As at:	1/12/2011	
Built Year		Inspected:	AVP Valuations - Jeff Cadd	
Fair Value	\$ 67,000.00	Contact Details	08 9328 3800	
Ownership Held			Expiry/Renewal Date:	1/12/2067
Lease Details				
Description	Iron and Iron Clad emergency services depot on concrete footings and slab with single roller door. Includes patio attached, ablutions paving and rainwater tanks.			
Comments

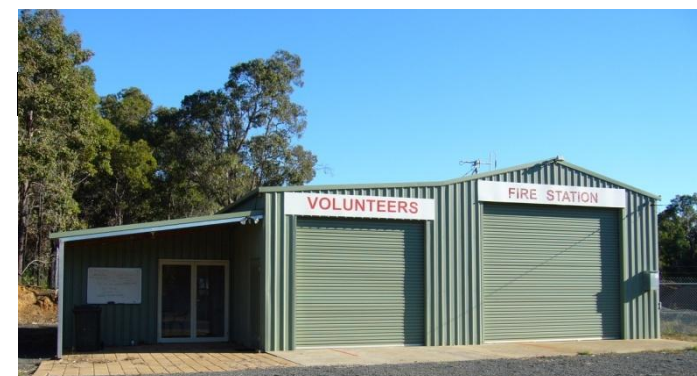
Asset Name	Nannup Brook Fire Station	Asset Number	B39	Core, Non-Core or Disposable Good 0 - 10 Poor Good 0 - 10 Poor
Type (B, L or E)	B	Asset Level	Core	
Address	East Nannup Road	Asset Condition	3	
Location	NANNUP	Acceptable Condition		
Reserve No:	R21220	Reserve Class:		
DOLA Plan		DOLA Pin		
Assessment No:		Legal Area		
Aerial View		MAP View		
Replacement Value	\$ 165,000.00	As at:	1/12/2011	
Built Year		Inspected:	AVP Valuations - Jeff Cadd	
Fair Value	\$ 116,000.00	Contact Details	08 9328 3800	
Ownership Held			Expiry/Renewal Date:	1/12/2072
Lease Details				
Description	Iron & Iron Clad emergency services depot on concrete footings with slab and two roller doors. Includes kitchenette, ablutions patio and concrete hard stand.			
Comments	Vested land that is used by both Depot and Nannup Brook brigade

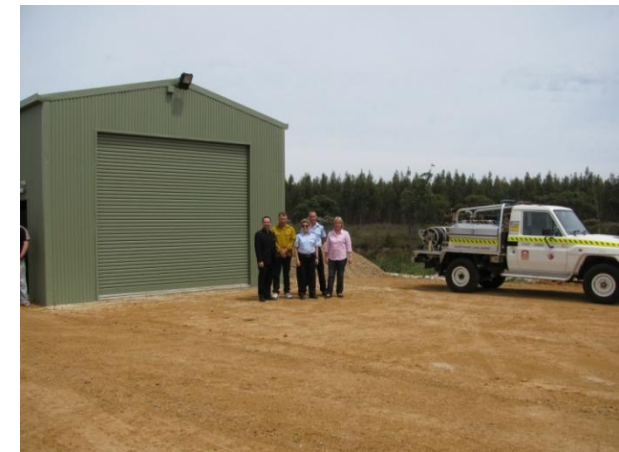
Asset Name	Scott River/Jasper Fire Shed	Asset Number	B46	Core, Non-Core or Disposable Good 0 - 10 Poor
Type (B, L or E)	B	Asset Level	Core	
Address	Governor Broome Road	Asset Condition	3	
Location	NANNUP	Acceptable Condition		
Reserve No:	R46141	Reserve Class:		
DOLA Plan		DOLA Pin		
Assessment No:		Legal Area		
Aerial View		MAP View		
Replacement Value	\$ 115,000.00	As at:	1/12/2011	
Built Year		Inspected:	AVP Valuations - Jeff Cadd	
Fair Value	\$ 90,000.00	Contact Details	08 9328 3800	
Ownership Held		Expiry/Renewal Date:	1/12/2081	
Lease Details				
Description	Iron and Iron Clad emergency services depot on concrete footings and slab with single roller door. Includes kitchenette, training room, ablutions and rainwater tank.			
Comments

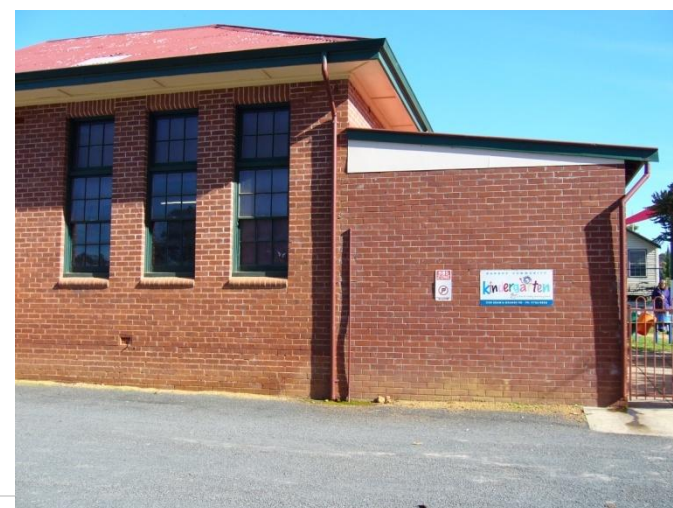
Asset Name	NANNUP Kindergarten	Asset Number	B9	
Type (B, L or E)	B	Asset Level	Non Core	Core, Non-Core or Disposable
Address	Cnr Adam Street & Grange Road	Asset Condition	3	Good 0 - 10 Poor
Location	NANNUP	Acceptable Condition		Good 0 - 10 Poor
Reserve No:		Reserve Class:		
DOLA Plan		DOLA Pin	647630	
Assessment No:	A3021	Legal Area		
Aerial View		MAP View		
Replacement Value	\$ 440,000.00	As at:	1/12/2011	
Built Year	Circa 1930 - Municipal Inventory 1996	Inspected:	AVP Valuations - Jeff Cadd	
Fair Value	\$ 174,000.00	Contact Details	08 9328 3800	
Ownership Held		Expiry/Renewal Date:	1/12/2050	
Lease Details				
Description	Brick, jarrah weatherboarded and iron clad, air conditioned kindergarten on concrete footings with timber floors.			
Comments	This building is listed within the Municipal Inventory (3.5.5) as originally being constructed as the first stage of the proposed new Nannup Primary School.

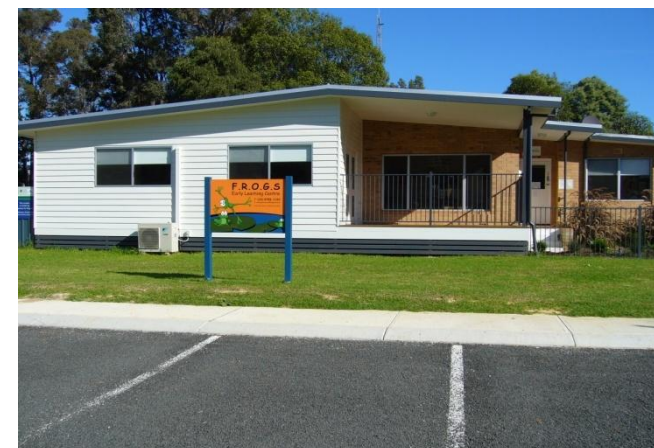
Asset Name	Frogs Early Learning Centre	Asset Number	B24	
Type (B, L or E)	B	Asset Level	Non-Core	Core, Non-Core or Disposable
Address	Grange Road	Asset Condition	0	Good 0 - 10 Poor
Location	NANNUP	Acceptable Condition		Good 0 - 10 Poor
Reserve No:		Reserve Class:		
DOLA Plan		DOLA Pin		
Assessment No:		Legal Area		
Aerial View		MAP View		
Replacement Value	\$ 540,000.00	As at:	Estimated	
Built Year		Inspected:		
Fair Value	\$ 540,000.00	Contact Details		
Ownership Held		Expiry/Renewal Date:	1/12/2091	
Lease Details				
Description	New Refurbishment of Grange Road Duplex Pair as at 2011/12.			
Comments

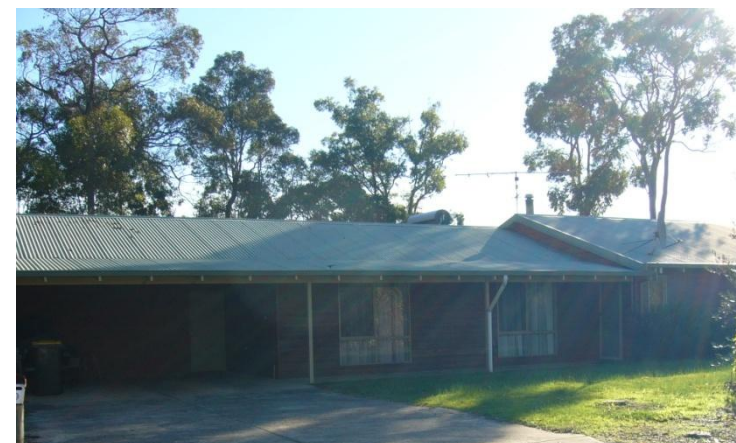
Asset Name	Dunnet Road House - Works Manager	Asset Number	B25	Core, Non-Core or Disposable
Type (B, L or E)	B	Asset Level	Non Core	
Address	Lot 234 Dunnet Road	Asset Condition	4	Good 0 - 10 Poor
Location	NANNUP	Acceptable Condition		Good 0 - 10 Poor
Reserve No:		Reserve Class:		
DOLA Plan		DOLA Pin		
Assessment No:		Legal Area		
Aerial View		MAP View		
Replacement Value	\$ 415,000.00	As at:	1/12/2011	
Built Year		Inspected:	AVP Valuations - Jeff Cadd	
Fair Value	\$ 125,000.00	Contact Details	08 9328 3800	
Ownership Held		Expiry/Renewal Date:	1/12/2061	
Lease Details	Residency Agreement			
Description	Three bedroom cedar weatherboard and iron clad air conditioned house on concrete footings and slab with a double carport and store under main roof.			
Comments

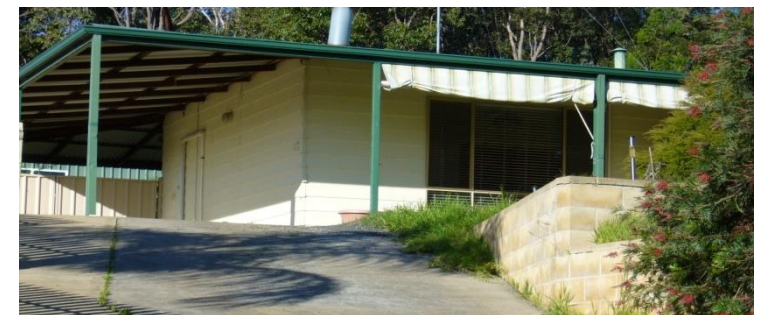
Asset Name	CEO Residence	Asset Number	B41	Core, Non-Core or Disposable Good 0 - 10 Poor Good 0 - 10 Poor
Type (B, L or E)	B	Asset Level	Non-Core	
Address	29 Carey Street	Asset Condition	3	
Location	NANNUP	Acceptable Condition		
Reserve No:		Reserve Class:		
DOLA Plan		DOLA Pin		
Assessment No:		Legal Area		
Aerial View		MAP View		
Replacement Value	\$ 315,000.00	As at:	1/12/2011	
Built Year		Inspected:	AVP Valuations - Jeff Cadd	
Fair Value	\$ 90,000.00	Contact Details	08 9328 3800	
Ownership Held		Expiry/Renewal Date:	1/12/2061	
Lease Details	Residency Agreement			
Description	Three bedroom fibro weatherboard and iron clad air conditioned house on concrete footings and slab with a single carport under main roof.			
Comments

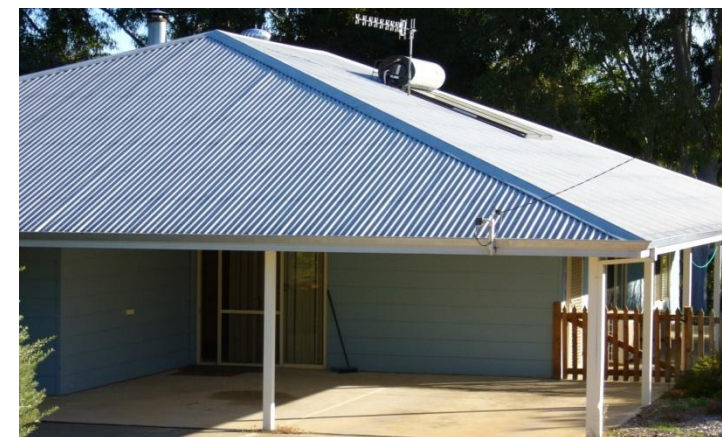
Asset Name	MCS Residence	Asset Number	B33	
Type (B, L or E)	B	Asset Level	Non-Core	Core, Non-Core or Disposable
Address	28 Carey Street	Asset Condition	3	Good 0 - 10 Poor
Location	NANNUP	Acceptable Condition		Good 0 - 10 Poor
Reserve No:		Reserve Class:		
DOLA Plan		DOLA Pin		
Assessment No:		Legal Area		
Aerial View		MAP View		
Replacement Value	\$355,000.00	As at:	1/12/2011	
Built Year		Inspected:	AVP Valuations - Jeff Cadd	
Fair Value	\$ 105,000.00	Contact Details	08 9328 3800	
Ownership Held		Expiry/Renewal Date:	1/12/2066	
Lease Details	Residency Agreement			
Description	Four Bedroom two bathroom fibro weatherboard and iron clad air conditioned house on concrete footings and slab with double carport under main roof.			
Comments

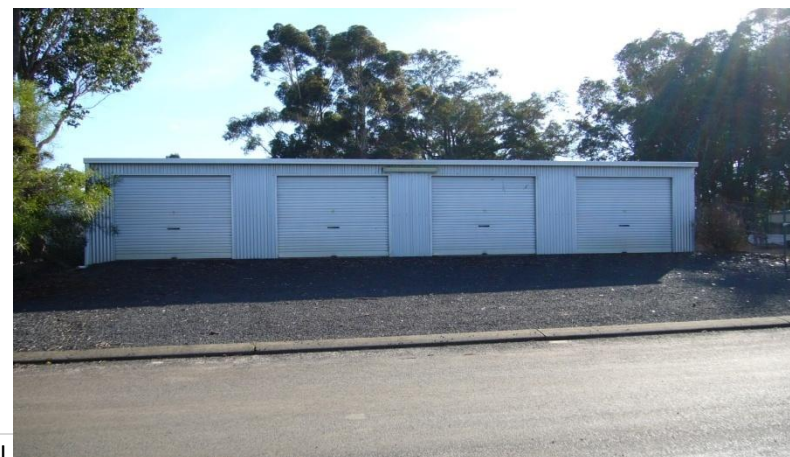
Asset Name	Community Storage Sheds	Asset Number	B44	
Type (B, L or E)	B	Asset Level	Disposable	Core, Non-Core or Disposable
Address	Kearney Street	Asset Condition	2	Good 0 - 10 Poor
Location	NANNUP	Acceptable Condition		Good 0 - 10 Poor
Reserve No:	R22637	Reserve Class:		
DOLA Plan		DOLA Pin		
Assessment No:		Legal Area		
Aerial View		MAP View		
Replacement Value	\$ 165,000.00	As at:	1/12/2011	
Built Year		Inspected:	AVP Valuations - Jeff Cadd	
Fair Value	\$ 125,000.00	Contact Details	08 9328 3800	
Ownership Held		Expiry/Renewal Date:	1/12/2066	
Lease Details				
Description	Iron and iron clad general purpose shed on concrete footings and slab with five roller doors.			
Comments	Includes bottle storage bins, oil receivable pad, rainwater tanks and boundary fencing.

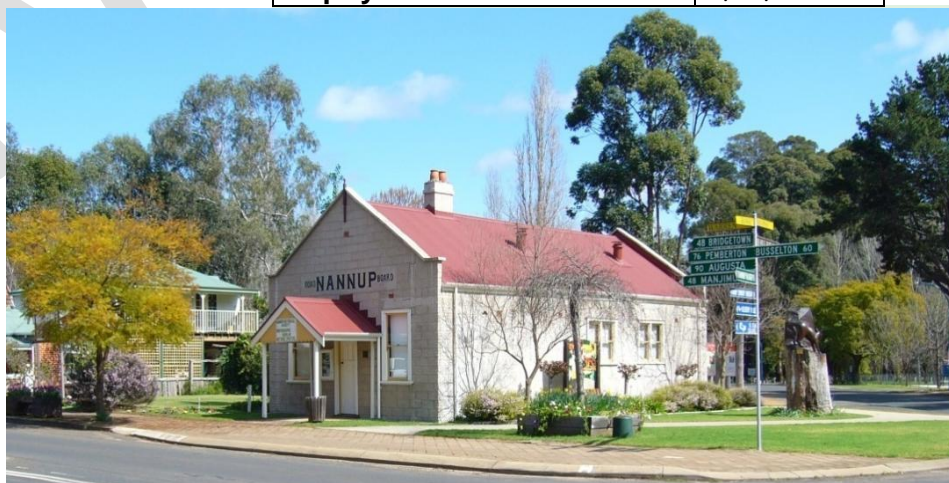
Asset Name	Old Roads Building	Asset Number	B1	Core, Non-Core or Disposable Good 0 - 10 Poor
Type (B, L or E)	B	Asset Level	Non-Core	
Address	Warren Road	Asset Condition	4	
Location	NANNUP	Acceptable Condition		
Reserve No:	R1788	Reserve Class:		
DOLA Plan Assessment No:		DOLA Pin		
Aerial View		Legal Area MAP View		
Replacement Value	\$ 340,000	As at:	1/12/2011	
Built Year		Inspected:	AVP Valuations - Jeff Cadd	
Fair Value	\$ 65,000	Contact Details	08 9328 3800	
Ownership Held		Expiry/Renewal Date:	1/12/2031	
Lease Details				
Description	Cement block and iron clad museum on concrete footings with timber floors			
Comments

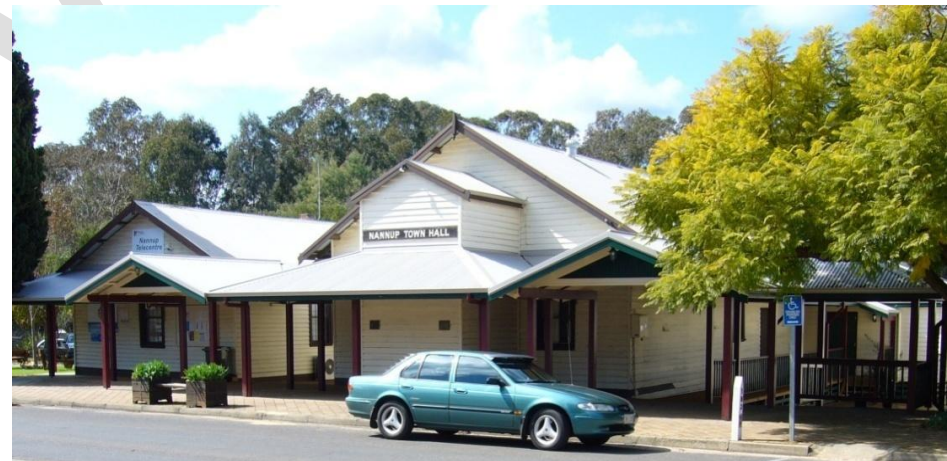
Asset Name	Town Hall	Asset Number	B3	Core, Non-Core or Disposable Good 0 - 10 Poor Good 0 - 10 Poor
Type (B, L or E)	B	Asset Level	Non Core	
Address	Warren Road	Asset Condition	6	
Location	NANNUP	Acceptable Condition		
Reserve No:	R3708	Reserve Class:		
DOLA Plan		DOLA Pin		
Assessment No:		Legal Area		
Aerial View		MAP View		
Replacement Value	\$1,500,000	As at:	1/12/2011	
Built Year	1903	Inspected:	AVP Valuations - Jeff Cadd	
Fair Value	500,000	Contact Details	08 9328 3800	
Ownership Held			Expiry/Renewal Date:	1/12/2041
Lease Details				
Description	Weatherboard timber and iron clad hall on timber footings with timber floors.			
Comments

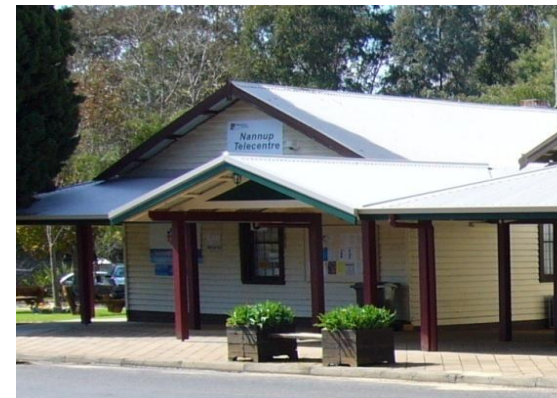
Asset Name Type (B, L or E)	Nannup Lesser Hall	Asset Number	B4	Core, Non-Core or Disposable
	B	Asset Level	Non Core	
Address	Warren Road	Asset Condition	4	
Location	NANNUP	Acceptable Condition		Good 0 - 10 Poor
Reserve No:	R3708	Reserve Class:		
DOLA Plan Assessment No:		DOLA Pin		
Aerial View		Legal Area MAP View		
Replacement Value	\$ 430,000.00	As at:	1/12/2011	
Built Year		Inspected:	AVP Valuations - Jeff Cadd	
Fair Value	\$ 100,000.00	Contact Details	08 9328 3800	
Ownership Held		Expiry/Renewal Date:	1/12/2031	
Lease Details	Leased by Nannup Music Club			
Description	Timber Weatherboard and iron clad air conditioned centre and office on timber footings with timber floors			
Comments	Expenses for Lesser hall have been combined with Town Hall expenditure historically.

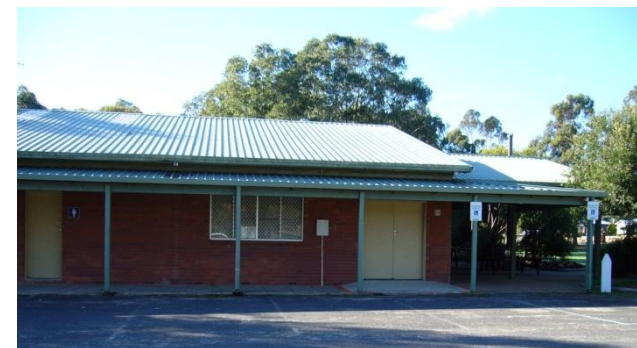
Asset Name	Community Centre	Asset Number	B12	Core, Non-Core or Disposable Good 0 - 10 Poor Good 0 - 10 Poor
Type (B, L or E)	B	Asset Level	Non Core	
Address	Warren Road	Asset Condition	5	
Location	NANNUP	Acceptable Condition		
Reserve No:	R9185	Reserve Class:		
DOLA Plan Assessment No:		DOLA Pin		
Aerial View		Legal Area MAP View		
Replacement Value	1,370,000.00 \$	As at:	1/12/2011	
Built Year		Inspected:	AVP Valuations - Jeff Cadd	
Fair Value	557,000.00 \$	Contact Details	08 9328 3800	
Ownership Held	Shire of Nannup	Expiry/Renewal Date:	1/12/2046	
Lease Details	Nannup Sports Association			
Description	Brick and Iron Clad community centre on concrete footings with concrete and timber floors			
Comments	Includes patio, pot belly stove and paving

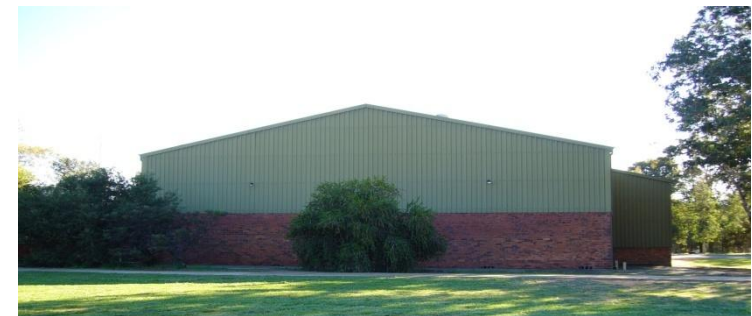
Asset Name	Nannup Recreation Centre	Asset Number	B13	Core, Non-Core or Disposable Good 0 - 10 Poor Good 0 - 10 Poor
Type (B, L or E)	B	Asset Level	Non Core	
Address	Warren Road	Asset Condition	7	
Location	NANNUP	Acceptable Condition		
Reserve No:	R9185	Reserve Class:		
DOLA Plan		DOLA Pin		
Assessment No:		Legal Area		
Aerial View		MAP View		
Replacement Value	\$ 2,300,000.00	As at:	1/12/2011	
Built Year		Inspected:	AVP Valuations - Jeff Cadd	
Fair Value	\$ 1,091,000.00	Contact Details	08 9328 3800	
Ownership Held		Expiry/Renewal Date:	1/12/2044	
Lease Details				
Description	Brick and Iron Clad recreation centre on concrete footings with timber floors			
Comments	Includes paving, cricket practice nets, oval floodlights and scorer's shelter. Costings include cost of maintenance of oval.

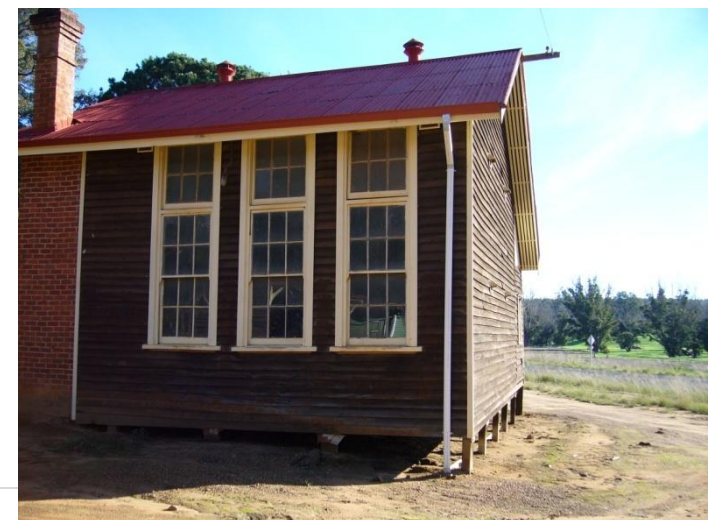
Asset Name	Cundinup Community Hall	Asset Number	B14	Core, Non-Core or Disposable Good 0 - 10 Poor Good 0 - 10 Poor
Type (B, L or E)	B	Asset Level	Disposable	
Address	Cundinup South Road	Asset Condition	10	
Location	11887 Cundinup, NANNUP	Acceptable Condition		
Reserve No:	R22979	Reserve Class:		
DOLA Plan		DOLA Pin		
Assessment No:		Legal Area	1.214 ha	
Aerial View		MAP View		
Replacement Value	250,000.00 \$	As at:	1/12/2011	
Built Year		Inspected:	AVP Valuations - Jeff Cadd	
Fair Value	17,000.00 \$	Contact Details	08 9328 3800	
Ownership Held			Expiry/Renewal Date:	1/12/2020
Lease Details				
Description	Timber framed weatherboard and iron clad community hall on timber footings with timber floors			
Comments	Includes detached weatherboard/iron shelter, toilet and rainwater tanks. Originally school for district. Is considered a risk management threat in relation to asbestos condition. Currently in state of disrepair. Included within the asbestos register.

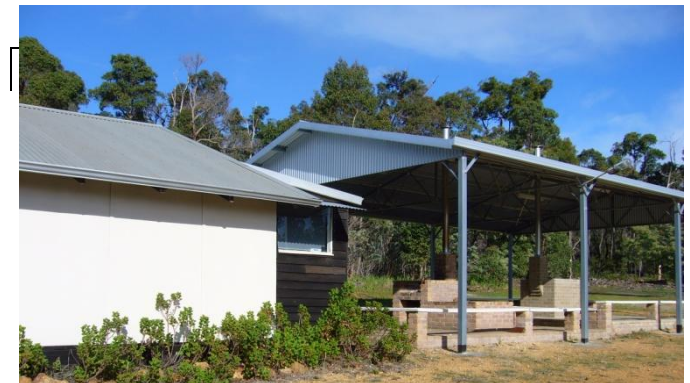
Asset Name	Carlotta Community Hall	Asset Number	B15	Core, Non-Core or Disposable Good 0 - 10 Poor Good 0 - 10 Poor
Type (B, L or E)	B	Asset Level	Disposable	
Address	Vasse Highway	Asset Condition	9	
Location	Carlotta, Nannup	Acceptable Condition		
Reserve No:	R20915	Reserve Class:		
DOLA Plan		DOLA Pin		
Assessment No:		Legal Area	2.0324 ha	
Aerial View		MAP View		
Replacement Value	\$ 200,000.00	As at:	1/12/2011	
Built Year	7/02/1952	Inspected:	AVP Valuations - Jeff Cadd	
Fair Value	\$ 74,000.00	Contact Details	08 9328 3800	
Ownership Held		Expiry/Renewal Date:	1/12/2045	
Lease Details				
Description	Asbestos and iron clad community hall on timber footings with timber floors.			
Comments	Asbestos considered being in good condition. Included within the Asbestos register.

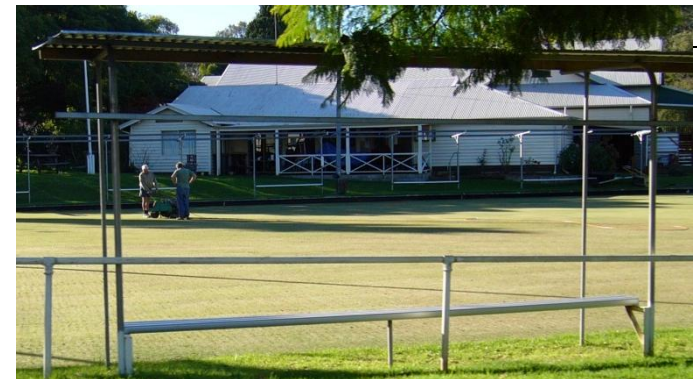
Asset Name	Bowling Club	Asset Number	B23	Core, Non-Core or Disposable Good 0 - 10 Poor Good 0 - 10 Poor
Type (B, L or E)	B	Asset Level	Non Core	
Address	Warren Road	Asset Condition	4	
Location	NANNUP	Acceptable Condition		
Reserve No:	R3708	Reserve Class:		
DOLA Plan		DOLA Pin		
Assessment No:		Legal Area	56.836	
Aerial View		MAP View	0	
Replacement Value	\$1,150,000.00	As at:	1/12/2011	
Built Year		Inspected:	AVP Valuations - Jeff Cadd	
Fair Value	446,000.00 \$	Contact Details	08 9328 3800	
Ownership Held		Expiry/Renewal Date:	1/12/2055	
Lease Details	Nannup Bowling Club			
Description	Timber weatherboard and iron clad air conditioned clubrooms on concrete footings and slab.			
Comments	Includes 7 rink grass bowling green, reticulation, floodlights, viewing shelters, attached patio and paving.

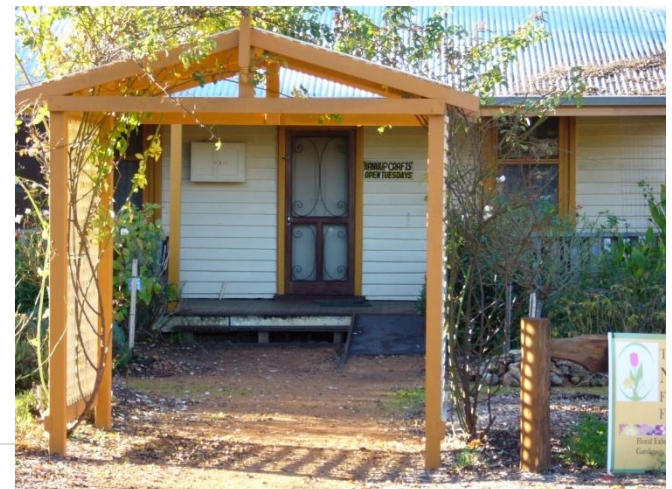
Asset Name	Community House - Brockman Street	Asset Number	B27	Core, Non-Core or Disposable Good 0 - 10 Poor
Type (B, L or E)	B	Asset Level	Disposable	
Address	Lot 107 Brockman Street	Asset Condition	5	
Location	NANNUP	Acceptable Condition		
Reserve No:	R865	Reserve Class:		
DOLA Plan		DOLA Pin		
Assessment No:		Legal Area		
Aerial View		MAP View		
Replacement Value	275,000.00 \$	As at:	1/12/2011	
Built Year	1923	Inspected:	AVP Valuations - Jeff Cadd	
Fair Value	\$ 75,000.00	Contact Details	08 9328 3800	
Ownership Held		Expiry/Renewal Date:	1/12/2035	
Lease Details				
Description	Timber weatherboard and iron clad community craft centre on timber footings with timber floors. Includes detached garage, garden portico, paving and fencing.			
Comments	Registered within Municipal Inventory (3.5.17) with management of site being listed as high level of protection appropriate.

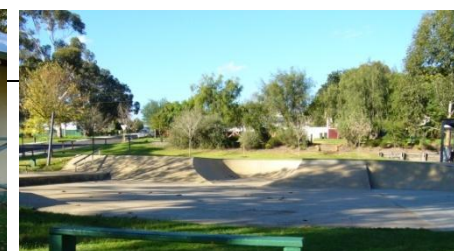
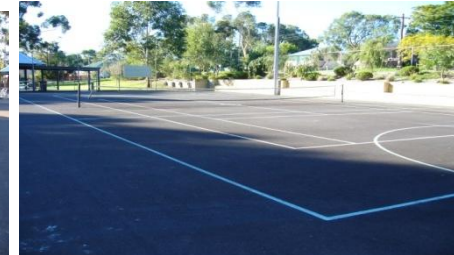
Asset Name	Skate park, Ablution Block and Sporting Facilities	Asset Number	B38 & IA5	Core, Non-Core or Disposable Good 0 - 10 Poor Good 0 - 10 Poor
Type (B, L or E)	B L E	Asset Level	Non Core	
Address	Warren Road	Asset Condition	6	
Location		Acceptable Condition		
Reserve No:	R9185	Reserve Class:		
DOLA Plan		DOLA Pin		
Assessment No:		Legal Area		
Aerial View		MAP View	0	
Replacement Value	\$ 325,000.00	As at:	1/12/2011	
Built Year		Inspected:	AVP Valuations - Jeff Cadd	
Fair Value	\$ 101,000.00	Contact Details	08 9328 3800	
Ownership Held		Expiry/Renewal Date:	1/12/2035	
Lease Details				
Description	Brick and iron clad toilet block on concrete footings and slab. Includes concrete skate park, gazebo with attached patio, a tennis court, basketball fencing, backboards, floodlights and paving.			
Comments

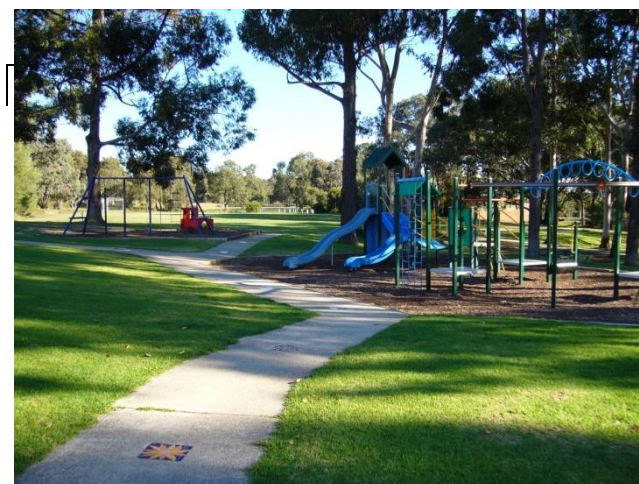
Asset Name	Marinko Tomas Playground	Asset Number	IA8	Core, Non-Core or Disposable Good 0 - 10 Poor Good 0 - 10 Poor
Type (B, L or E)	B, L & E	Asset Level	Non Core	
Address	Warren Road	Asset Condition	3	
Location		Acceptable Condition		
Reserve No:	R9185	Reserve Class:		
DOLA Plan Assessment No:		DOLA Pin		
Aerial View		Legal Area MAP View		
Replacement Value	1,421,699.00 \$	As at:	1/12/2011	
Built Year		Inspected:	AVP Valuations - Jeff Cadd	
Fair Value	826,436.00 \$	Contact Details	08 9328 3800	
Ownership Held		Expiry/Renewal Date:	1/12/2080	
Lease Details				
Description	Includes playground equipment, picnic shelters and facilities. Timber framed and iron clad picnic shelter on concrete footings and slab.			
Comments

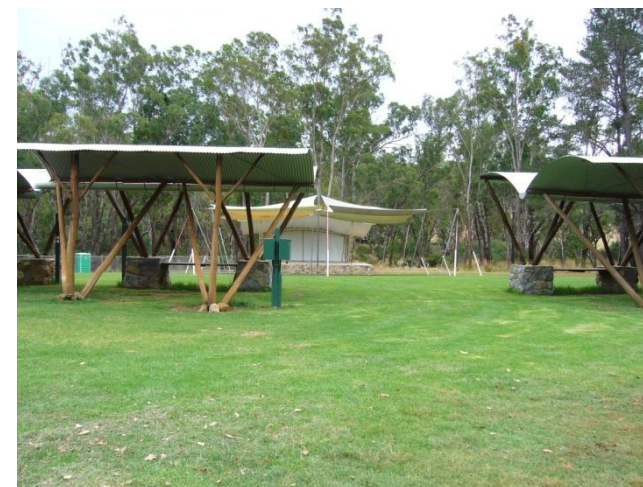
Asset Name	Foreshore Amphitheatre	Asset Number	TBA	Core, Non-Core or Disposable Good 0 - 10 Poor Good 0 - 10 Poor
Type (B, L or E)	BL	Asset Level	Non Core	
Address	Brockman Street	Asset Condition	2	
Location	NANNUP	Acceptable Condition		
Reserve No:	R24774	Reserve Class:		
DOLA Plan		DOLA Pin		
Assessment No:		Legal Area		
Aerial View		MAP View		
Replacement Value	\$ 255,000.00	As at:	1/12/2011	
Built Year		Inspected:	AVP Valuations - Jeff Cadd	
Fair Value	\$ 165,000.00	Contact Details	08 9328 3800	
Ownership Held		Expiry/Renewal Date:	1/12/2046	
Lease Details				
Description	Amphitheatre consists of steel framed vinyl clad amphitheatre on stone and concrete footings with raised concrete stage.			
Comments

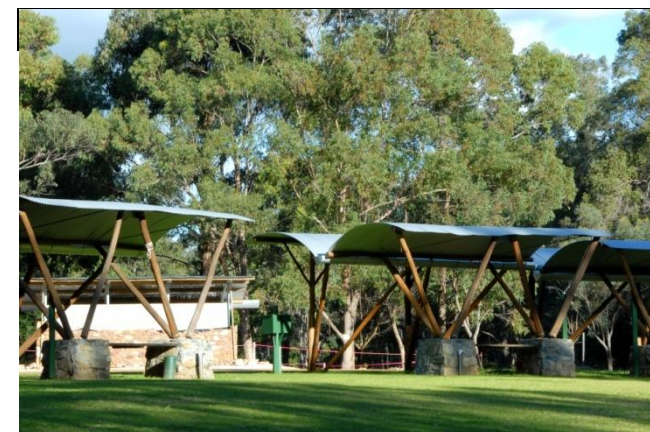
Asset Name	Foreshore Park Picnic Shelters	Asset Number	TBA	Core, Non-Core or Disposable Good 0 - 10 Poor Good 0 - 10 Poor
Type (B, L or E)	BL	Asset Level	Non Core	
Address	Brockman Street	Asset Condition	2	
Location	NANNUP	Acceptable Condition		
Reserve No:	R24774	Reserve Class:		
DOLA Plan		DOLA Pin		
Assessment No:		Legal Area		
Aerial View		MAP View		
Replacement Value	\$ 255,000.00	As at:	1/12/2011	
Built Year		Inspected:	AVP Valuations - Jeff Cadd	
Fair Value	\$ 165,000.00	Contact Details	08 9328 3800	
Ownership Held		Expiry/Renewal Date:	1/12/2066	
Lease Details				
Description	Picnic shelters consist of eight timber framed and iron clad picnic shelters on stone and concrete footings with turf flooring. Includes two information bays and new picnic shelter with bbq.			
Comments

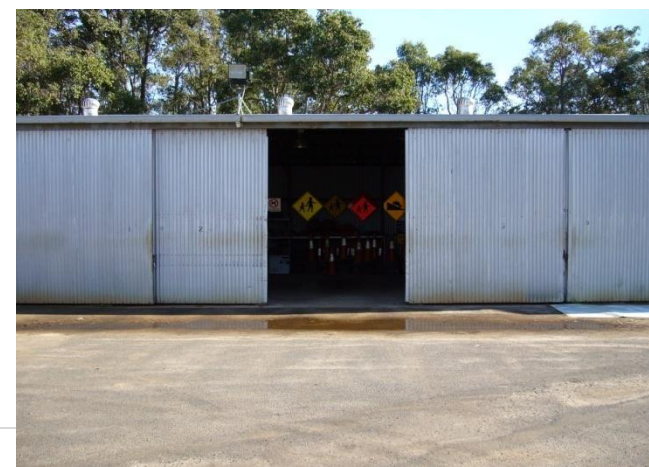
Asset Name	Works Depot Sign Shed	Asset Number	TBA	Core, Non-Core or Disposable Good 0 - 10 Poor
Type (B, L or E)	B	Asset Level	Core	
Address		Asset Condition	2	
Location	NANNUP	Acceptable Condition		
Reserve No:	R22637	Reserve Class:		
DOLA Plan Assessment No:		DOLA Pin		
Aerial View		Legal Area		
		MAP View		
Replacement Value	150,000.00 \$	As at:	1/12/2011	
Built Year		Inspected:	AVP Valuations - Jeff Cadd	
Fair Value	\$ 95,000.00	Contact Details	08 9328 3800	
Ownership Held		Expiry/Renewal Date:	1/12/2065	
Lease Details				
Description	Iron & Iron Clad general purpose shed on concrete footings and slab with sliding doors			
Comments

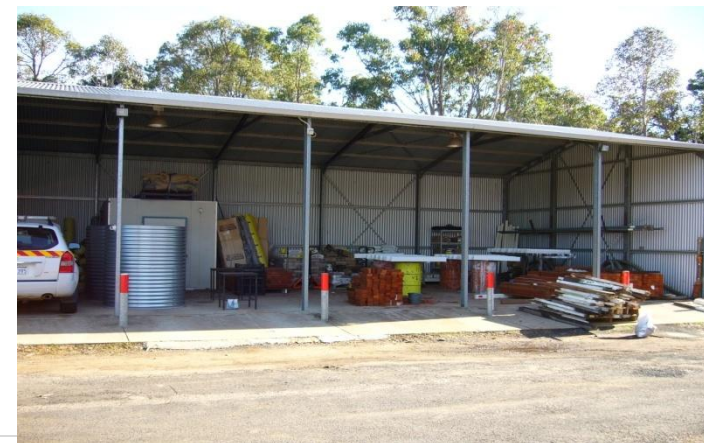
Asset Name	Depot Tractor & Machinery Shed	Asset Number	B8	Core, Non-Core or Disposable Good 0 - 10 Poor
Type (B, L or E)	B	Asset Level	Core	
Address	Kearney Street	Asset Condition	1	
Location	NANNUP	Acceptable Condition		
Reserve No:	R22637	Reserve Class:		
DOLA Plan		DOLA Pin		
Assessment No:		Legal Area		
Aerial View		MAP View		
Replacement Value	\$ 115,000.00	As at:	1/12/2011	
Built Year		Inspected:	AVP Valuations - Jeff Cadd	
Fair Value	\$ 63,000.00	Contact Details	08 9328 3800	
Ownership Held		Expiry/Renewal Date:	1/12/2060	
Lease Details				
Description	Iron and iron clad general purpose open fronted shed on a concrete footing and slab.			
Comments	Includes concrete hardstand.

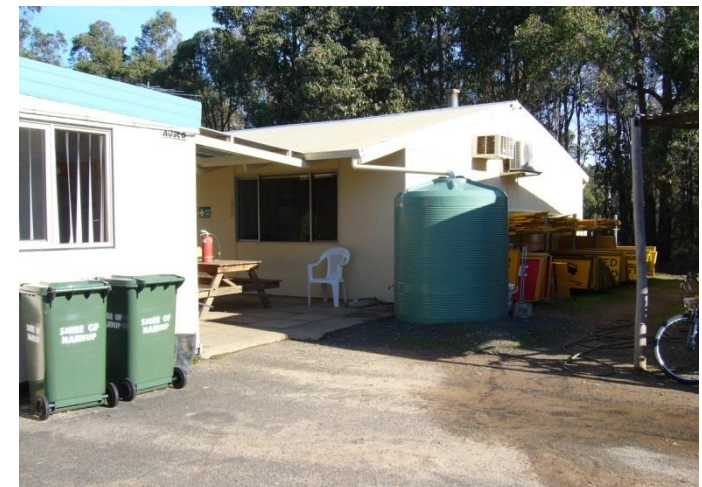
Asset Name	Depot Amenities & Crib Room	Asset Number	B7	Core, Non-Core or Disposable Good 0 - 10 Poor
Type (B, L or E)	B	Asset Level	Core	
Address	Kearney Street	Asset Condition	5	
Location	NANNUP	Acceptable Condition		
Reserve No:	R22637	Reserve Class:		Good 0 - 10 Poor
DOLA Plan		DOLA Pin		
Assessment No:		Legal Area		
Aerial View		MAP View		
Replacement Value	\$ 210,000.00	As at:	1/12/2011	
Built Year		Inspected:	AVP Valuations - Jeff Cadd	
Fair Value	\$ 137,000.00	Contact Details	08 9328 3800	
Ownership Held		Expiry/Renewal Date:	1/12/2060	
Lease Details				
Description	Asbestos and iron clad amenities building on concrete footing and slab			
Comments	Includes attached patio, paving barbeque water cooler and poly rain tank.

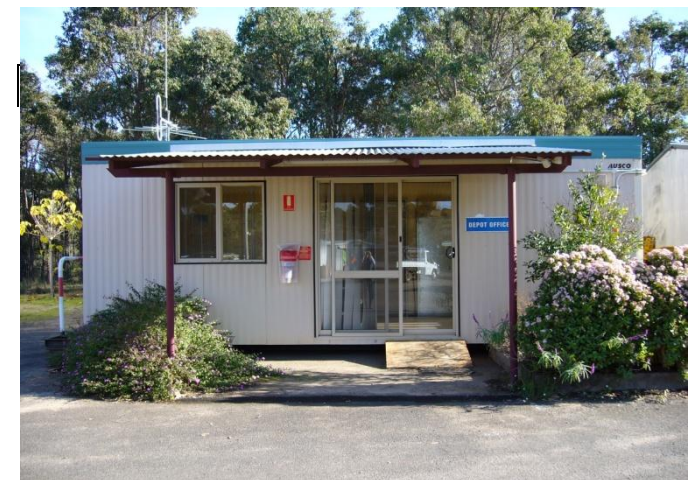
Asset Name	Works Depot Administration Office	Asset Number	TBA	
Type (B, L or E)	B	Asset Level	Core	Core, Non-Core or Disposable
Address	Kearney Street	Asset Condition	4	Good 0 - 10 Poor
Location	NANNUP	Acceptable Condition		Good 0 - 10 Poor
Reserve No:	R22637	Reserve Class:		
DOLA Plan		DOLA Pin		
Assessment No:		Legal Area		
Aerial View		MAP View		
Replacement Value	\$ 32,000.00	As at:	1/12/2011	
Built Year		Inspected:	AVP Valuations - Jeff Cadd	
Fair Value	\$ 22,000.00	Contact Details	08 9328 3800	
Ownership Held		Expiry/Renewal Date:	1/12/2060	
Lease Details				
Description	Iron & Iron Clad air conditioned transportable office on steel footings with timber floors.			
Comments	Includes attached patio. Need to check as this is currently not being depreciated.

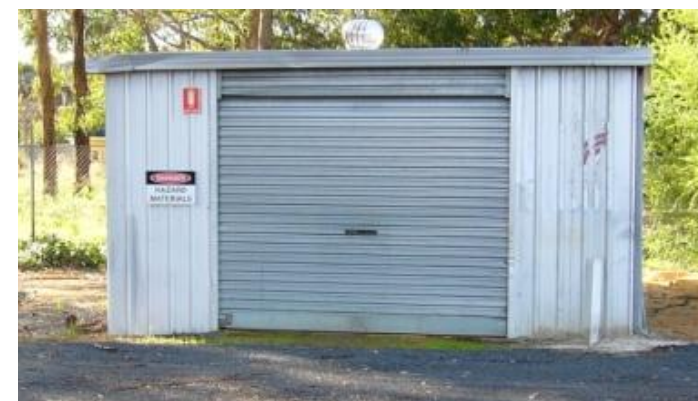
Asset Name	Works Depot Chemical Store Shed	Asset Number	TBA	
Type (B, L or E)	B	Asset Level	Core	Core, Non-Core or Disposable
Address	Kearney Street	Asset Condition	1	Good 0 - 10 Poor
Location	NANNUP	Acceptable Condition		Good 0 - 10 Poor
Reserve No:		Reserve Class:		
DOLA Plan		DOLA Pin	648461	
Assessment No:		Legal Area		
Aerial View		MAP View		
Replacement Value	\$ 12,000.00	As at:	1/12/2011	
Built Year		Inspected:	AVP Valuations - Jeff Cadd	
Fair Value	\$ 8,000.00	Contact Details	08 9328 3800	
Ownership Held		Expiry/Renewal Date:	1/12/2060	
Lease Details				
Description	Iron and iron clad single garage on concrete footings and slab with roller door			
Comments	Not shown on depreciation schedule.

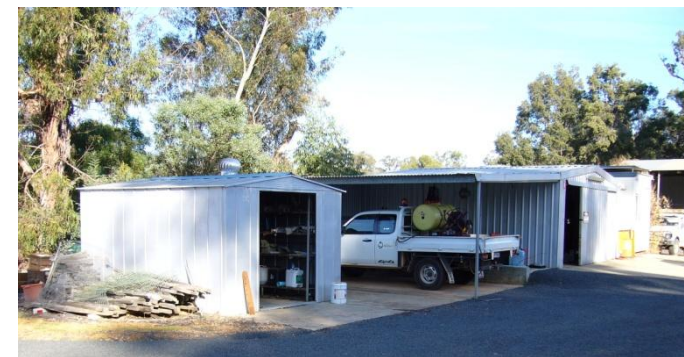
Asset Name	Works Depot - Gardeners Shed & Office	Asset Number	TBA	Core, Non-Core or Disposable Good 0 - 10 Poor Good 0 - 10 Poor
Type (B, L or E)	B	Asset Level	Core	
Address	731 Cullen Street	Asset Condition	2	
Location	NANNUP	Acceptable Condition		
Reserve No:	R22637	Reserve Class:		
DOLA Plan		DOLA Pin		
Assessment No:		Legal Area		
Aerial View		MAP View		
Replacement Value	\$ 60,000	As at:	1/12/2011	
Built Year		Inspected:	AVP Valuations - Jeff Cadd	
Fair Value		Contact Details	08 9328 3800	
Ownership Held		Expiry/Renewal Date:		1/12/2060
Lease Details				
Description	Iron and iron clad general purpose shed on concrete footings and slab with sliding doors.			
Comments	Includes garden shed, carport attached, transportable office, shade houses and storage. Not shown on depreciation schedule.

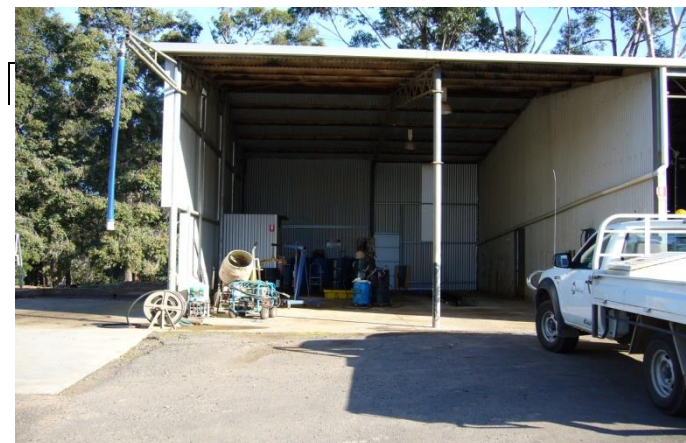
Asset Name	Works Depot - Fire Tank Store	Asset Number	TBA	Core, Non-Core or Disposable Good 0 - 10 Poor Good 0 - 10 Poor
Type (B, L or E)	B	Asset Level	Core	
Address	732 Cullen Street	Asset Condition	2	
Location	NANNUP	Acceptable Condition		
Reserve No:		Reserve Class:		
DOLA Plan		DOLA Pin	648463	
Assessment No:		Legal Area		
Aerial View		MAP View		
Replacement Value	\$ 20,000.00	As at:	1/12/2011	
Built Year		Inspected:	AVP Valuations - Jeff Cadd	
Fair Value	\$ 16,000.00	Contact Details	08 9328 3800	
Ownership Held		Expiry/Renewal Date:	1/12/2069	
Lease Details				
Description	Iron and iron clad open ended general purpose shed on concrete footings with concrete bitumen floors, loading dock.			
Comments	Not included within depreciation schedule

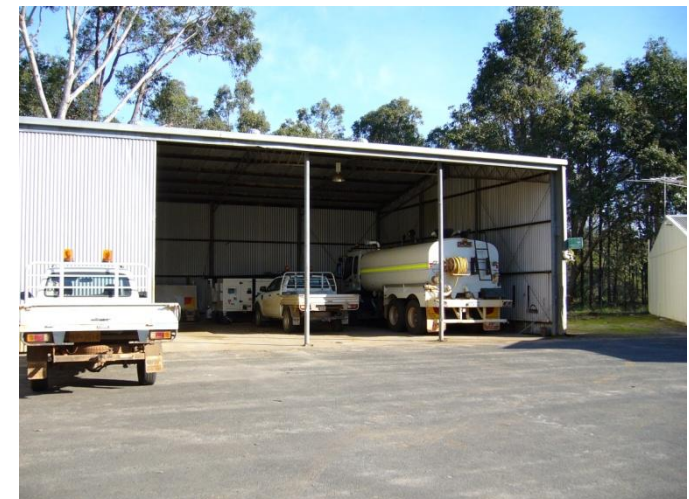
Asset Name	Works Depot Truck Store Building	Asset Number	TBA	Core, Non-Core or Disposable Good 0 - 10 Poor Good 0 - 10 Poor
Type (B, L or E)	B	Asset Level	Core	
Address		Asset Condition	2	
Location	NANNUP	Acceptable Condition		
Reserve No:	R22637	Reserve Class:		
DOLA Plan		DOLA Pin		
Assessment No:		Legal Area		
Aerial View		MAP View		
Replacement Value	\$ 90,000.00	As at:	1/12/2011	
Built Year		Inspected:	AVP Valuations - Jeff Cadd	
Fair Value	\$ 74,000.00	Contact Details	08 9328 3800	
Ownership Held		Expiry/Renewal Date:	1/12/2070	
Lease Details				
Description	Iron and iron clad open ended general purpose shed on concrete footings with part bitumen ad part gravel floors.			
Comments	Not included within depreciation schedule

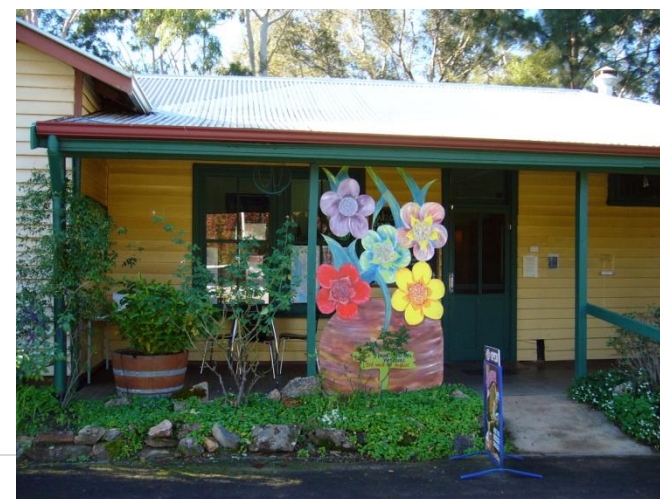
Asset Name	Caravan Park Administration Building	Asset Number	B16	Core, Non-Core or Disposable Good 0 - 10 Poor
Type (B, L or E)	B	Asset Level	Non Core	
Address	Brockman Road	Asset Condition		
Location	NANNUP	Acceptable Condition		
Reserve No:	R865	Reserve Class:		Good 0 - 10 Poor
DOLA Plan		DOLA Pin		
Assessment No:		Legal Area		
Aerial View		MAP View		
Replacement Value	\$ 550,000.00	As at:	1/12/2011	
Built Year	Circa 1923	Inspected:	AVP Valuations - Jeff Cadd	
Fair Value	\$ 161,000.00	Contact Details	08 9328 3800	
Ownership Held	Caravan Park Administration Building	Expiry/Renewal Date:	1/12/2040	
Lease Details				
Description	Timber weatherboard and iron clad air conditioned tourist centre on timber footings with timber floors			
Comments	Includes fencing, paving, shelter BBQ and three tables with seats. Part of Municipal Inventory and has heritage status. Formerly known as the Nannup Police Station.

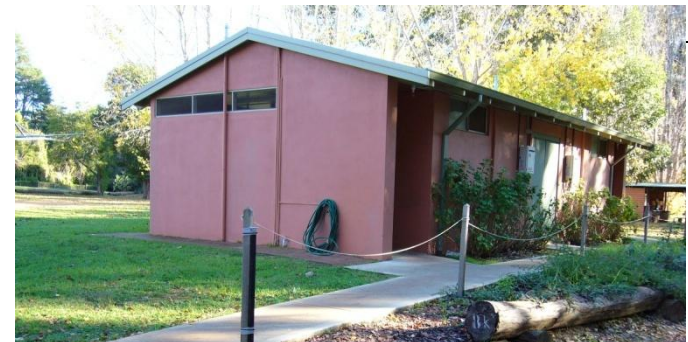
Asset Name	Brockman Street Caravan Park Ablution Block	Asset Number	B18	Core, Non-Core or Disposable Good 0 - 10 Poor
Type (B, L or E)	B	Asset Level	Non Core	
Address	Brockman Street Caravan Park	Asset Condition	4	
Location	NANNUP	Acceptable Condition		
Reserve No:	R865	Reserve Class:		
DOLA Plan		DOLA Pin		
Assessment No:		Legal Area		
Aerial View		MAP View		
Replacement Value	\$ 240,000.00	As at:	1/12/2011	
Built Year		Inspected:	AVP Valuations - Jeff Cadd	
Fair Value	\$ 155,000.00	Contact Details	08 9328 3800	
Ownership Held		Expiry/Renewal Date:	1/12/2055	
Lease Details				
Description	Brick and iron clad ablution block on concrete footings and slab.			
Comments	Includes patio and paving

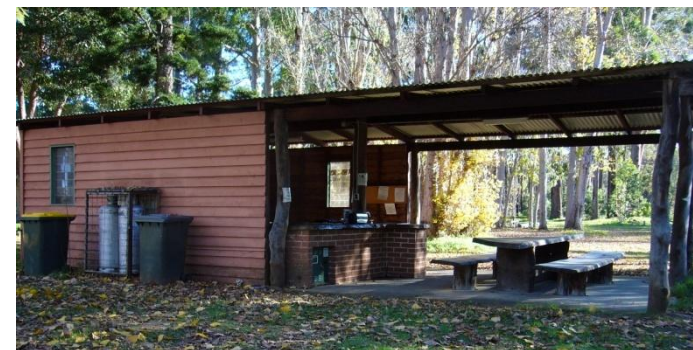
Asset Name	Brockman Street Caravan Park + Camp Kitchen	Asset Number	B19	
Type (B, L or E)	B L	Asset Level	Non Core	Core, Non-Core or Disposable
Address	Brockman Street Caravan Park	Asset Condition	4	Good 0 - 10 Poor
Location	NANNUP	Acceptable Condition		Good 0 - 10 Poor
Reserve No:	R865	Reserve Class:		
DOLA Plan		DOLA Pin		
Assessment No:		Legal Area		
Aerial View		MAP View		
Replacement Value	\$ 50,000.00	As at:	1/12/2011	
Built Year		Inspected:	AVP Valuations - Jeff Cadd	
Fair Value	\$ 17,000.00	Contact Details	08 9328 3800	
Ownership Held		Expiry/Renewal Date:	1/12/2055	
Lease Details				
Description	Timber weatherboard and iron clad campers kitchen on concrete footings and slab.			
Comments	Includes gas bbq, paving and three picnic tables with seats. ***Value of actual caravan park not recorded to date. Needs Updating***

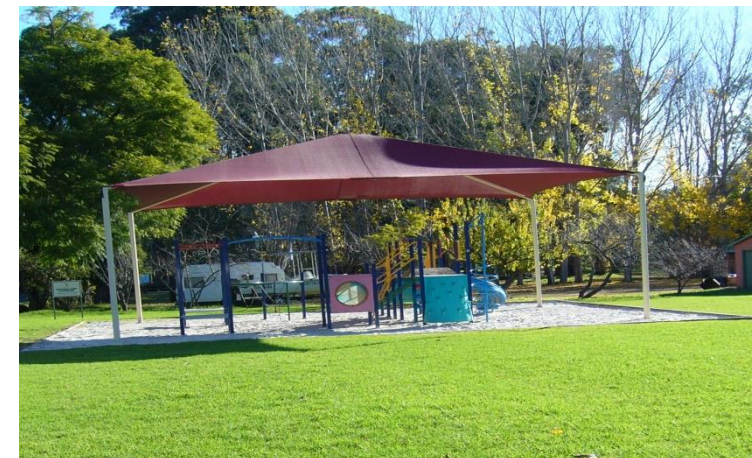
Asset Name	Brockman Street Playground	Asset Number	TBA	
Type (B, L or E)	E	Asset Level	Disposable	Core, Non-Core or Disposable
Address	Brockman Street Playground	Asset Condition	3	Good 0 - 10 Poor
Location	NANNUP	Acceptable Condition		Good 0 - 10 Poor
Reserve No:	R20333	Reserve Class:		
DOLA Plan		DOLA Pin		
Assessment No:		Legal Area		
Aerial View		MAP View		
Replacement Value	\$ 27,000.00	As at:	1/12/2011	
Built Year		Inspected:	AVP Valuations - Jeff Cadd	
Fair Value	\$ 21,000.00	Contact Details	08 9328 3800	
Ownership Held		Expiry/Renewal Date:	1/12/2029	
Lease Details				
Description	Includes steel framed and shade sail cloth clad shade shelter.			
Comments

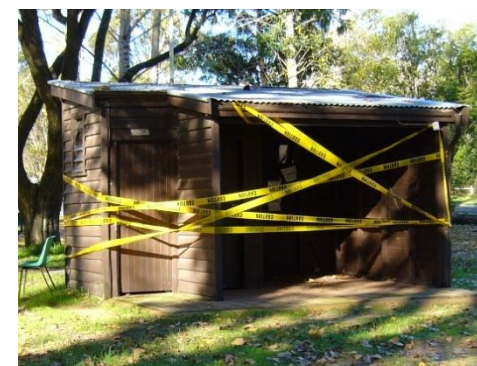
Asset Name	Brockman Street Caravan Park Timber Toilets	Asset Number	B20	
Type (B, L or E)	B	Asset Level	Disposable	Core, Non-Core or Disposable
Address	Brockman Street	Asset Condition	4	Good 0 - 10 Poor
Location	NANNUP	Acceptable Condition		Good 0 - 10 Poor
Reserve No:	R20333	Reserve Class:		
DOLA Plan		DOLA Pin		
Assessment No:		Legal Area		
Aerial View		MAP View		
Replacement Value	\$ 32,000.00	As at:	1/12/2011	
Built Year		Inspected:	AVP Valuations - Jeff Cadd	
Fair Value	\$ 9,000.00	Contact Details	08 9328 3800	
Ownership Held		Expiry/Renewal Date:	1/12/2029	
Lease Details	Nannup Visitors Centre			
Description	Timber Weatherboard and Iron Clad toilet block on timber footings with concrete footings			
Comments

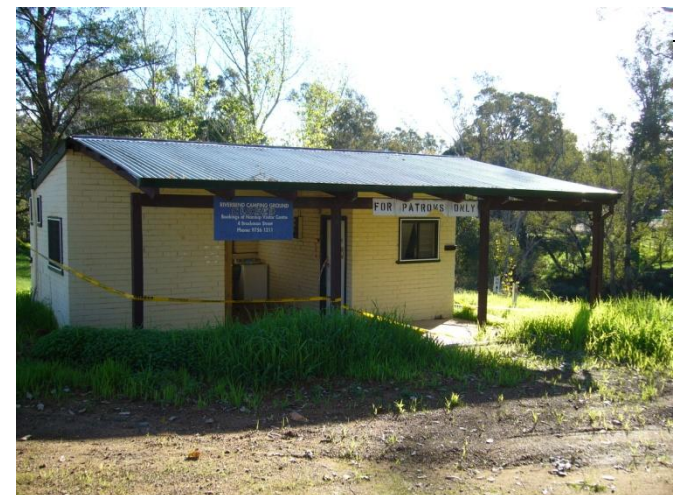
Asset Name	Riversbend Caravan Park Old Ablution Block	Asset Number	B21	Core, Non-Core or Disposable Good 0 - 10 Poor
Type (B, L or E)	B	Asset Level	Disposable	
Address	Balingup Road	Asset Condition	4	
Location	NANNUP	Acceptable Condition		
Reserve No:	R24762	Reserve Class:		
DOLA Plan		DOLA Pin		
Assessment No:		Legal Area		
Aerial View		MAP View		
Replacement Value	\$ 145,000.00	As at:	1/12/2011	
Built Year		Inspected:	AVP Valuations - Jeff Cadd	
Fair Value	\$ 8,000.00	Contact Details	08 9328 3800	
Ownership Held		Expiry/Renewal Date:	1/12/2016	
Lease Details				
Description	Brick & Iron Clad ablutions block on concrete footings and slab			
Comments	Includes attached patio and paving.

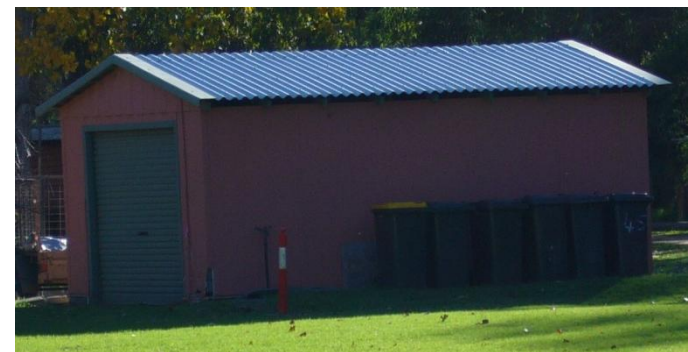
Asset Name	Garage/Storage Shed - remains of Eric's Cottage	Asset Number	B22	Core, Non-Core or Disposable Good 0 - 10 Poor Good 0 - 10 Poor
Type (B, L or E)	B	Asset Level	Disposable	
Address	Brockman Street	Asset Condition	7	
Location	NANNUP	Acceptable Condition		
Reserve No:	R20333	Reserve Class:		
DOLA Plan		DOLA Pin		
Assessment No:		Legal Area		
Aerial View		MAP View		
Replacement Value	\$ 10,000.00	As at:	1/12/2011	
Built Year		Inspected:	AVP Valuations - Jeff Cadd	
Fair Value	\$ 3,000.00	Contact Details	08 9328 3800	
Ownership Held		Expiry/Renewal Date:	1/12/2035	
Lease Details				
Description	Timber framed asbestos and asbestos clad single garage on concrete footings and slab with roller door access.			
Comments

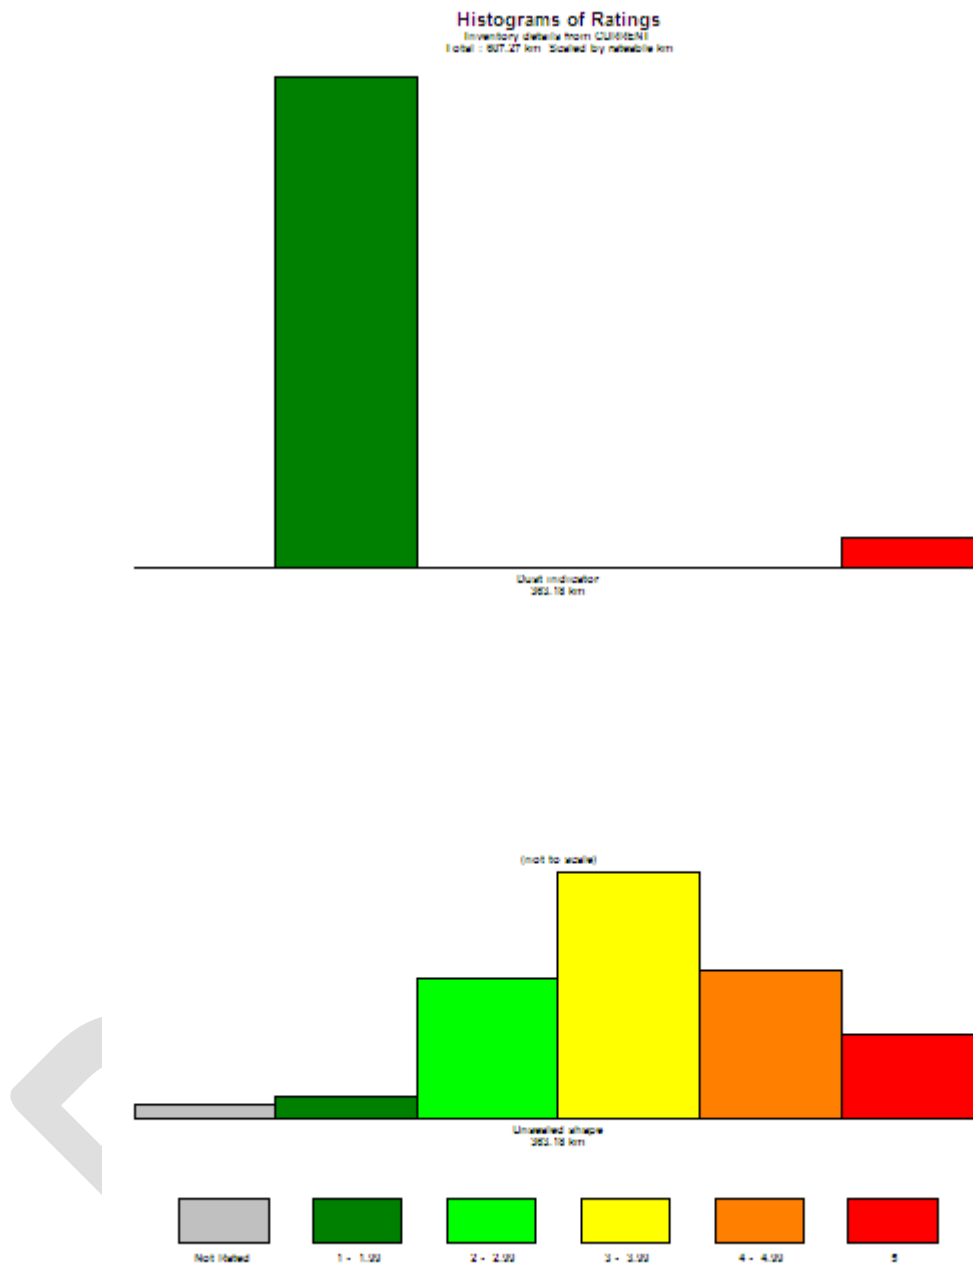
This graph indicates that our networks requires some gravel resheeting works, but mainly shows that resources should be directed to improving the maintenance grading procedure and techniques to reshape the road crown.

It is recommended that the Shire prepare a 5 year gravel resheeting program to address the shape and depth of material. The Shire also should prepare a routine maintenance grading program to avoid long delays between routine grading of busy roads.
