Shire of
Nannup
rest • connect • grow

Asset Management Plan

2013-2023

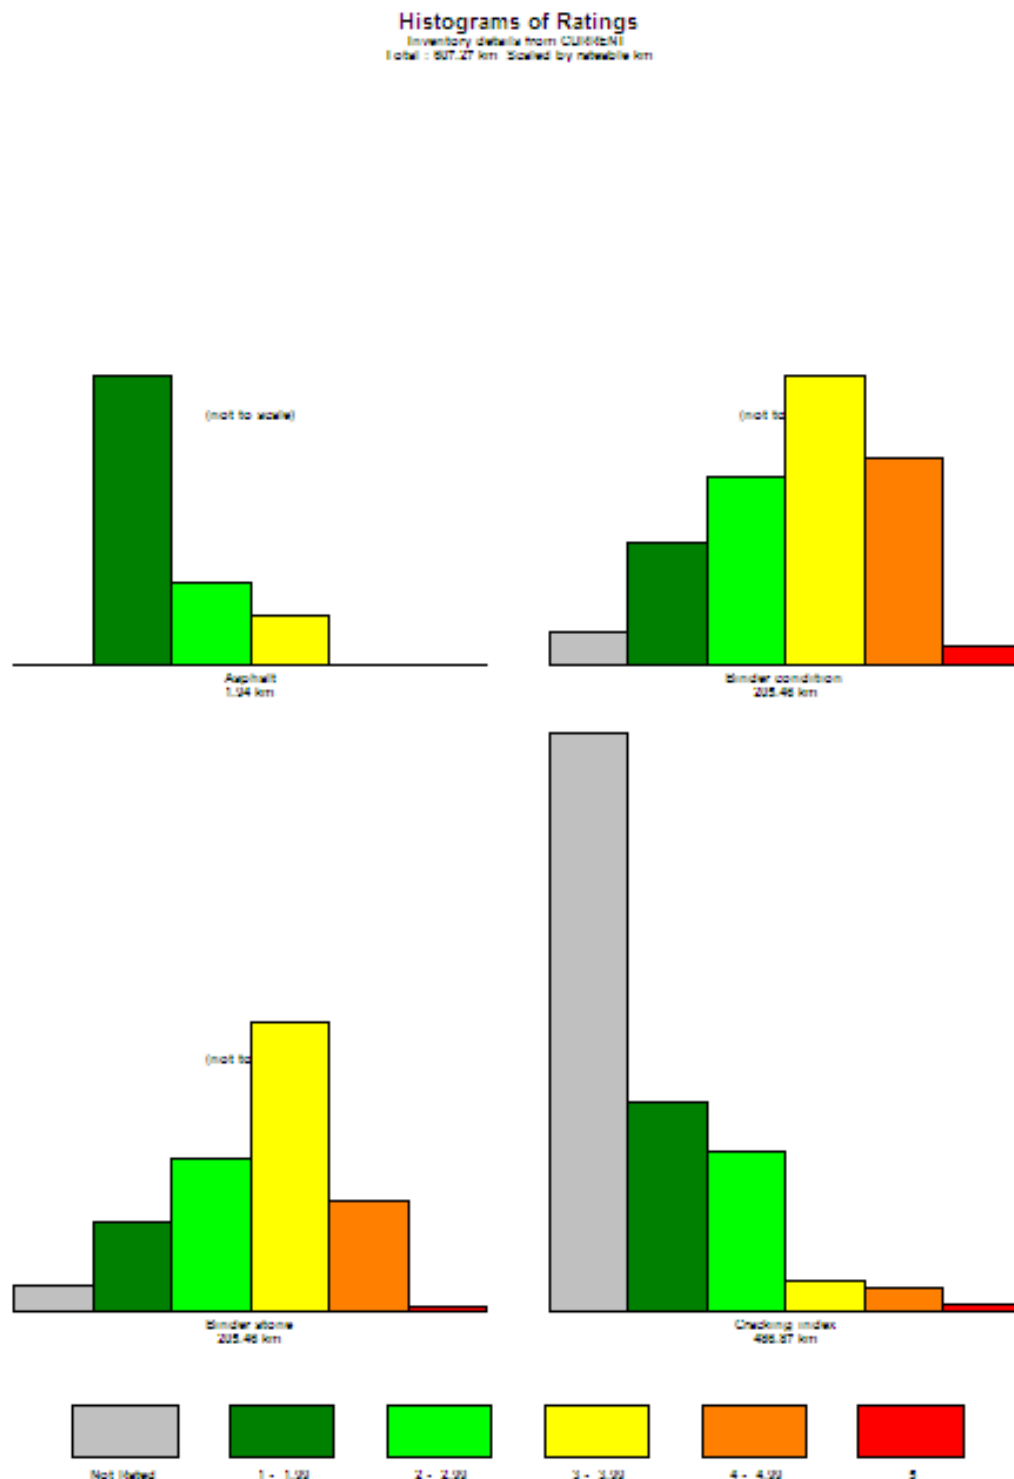
This graph indicates that our network contains some seal stripping which seems to be equally attributed to binder and stone application specification. It is recommended that the Shire review its binder and stone application specifications individually with each project. Attention should be paid to traffic type, seasonal influences and bitumen specification.

These graphs also indicate that the Shire should prepare a 5 year reseal program to address future failures.
